Defence Baseline Report

Prepared for

Slapton Line
Partnership

September 2017

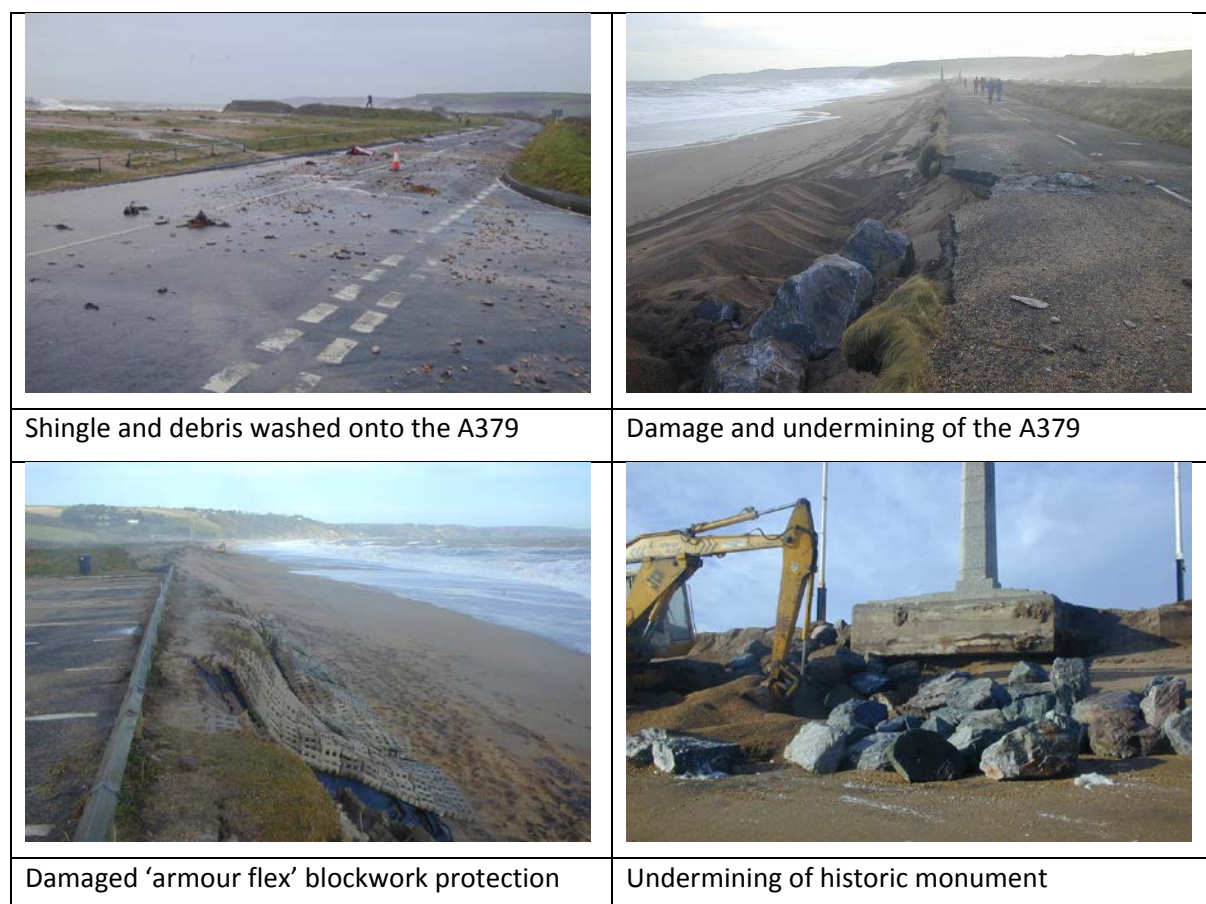
| Year | Construction/ Event | Description | Source |
|---|--|--|--|
| Jan 2001 | Storm | Severe storms in January 2001 caused a reduction in the crest width of 5m over a length of 1,000m. The erosion undermined a 200m length of the A379, north of the junction with Sands Road, resulting in the temporary closure of the road (see Figure 2.2). | |

Figure 2.2 2001 storm damage at various locations along the BMP frontage

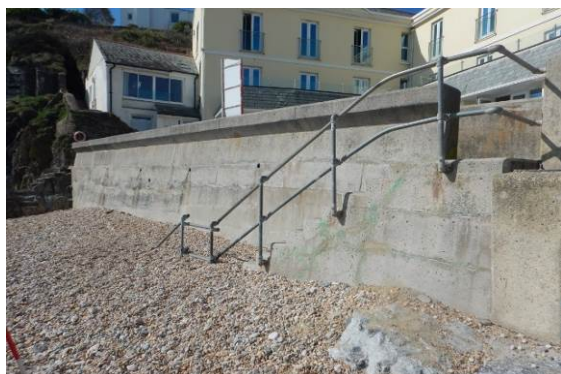
Concrete seawall with access steps

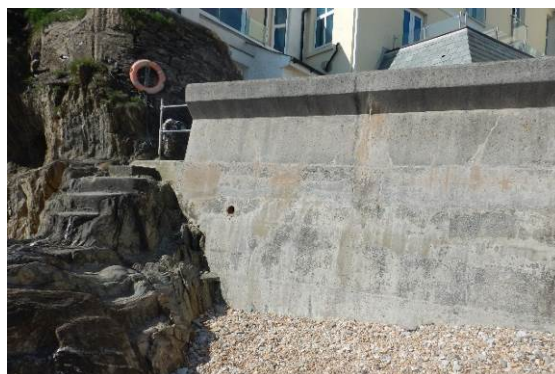
Southern end embedded into bedrock/cliff

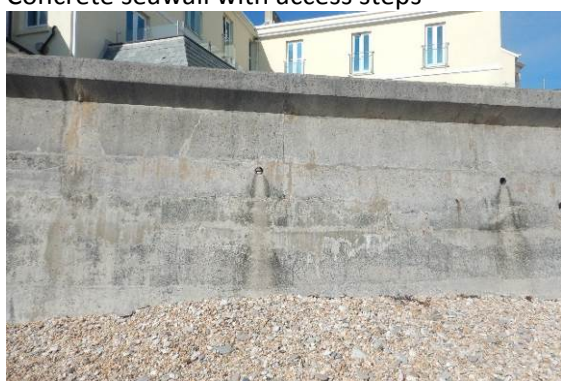
Middle section showing rust staining and surface cracking

Condition Description: The wall has minor rust staining and surface cracking with one minor void (approx. 100mm diameter) and patch repairs apparent at various location. However, there was no evidence of structural movement or slumping.

Condition Grade: Grade 2 – GOOD

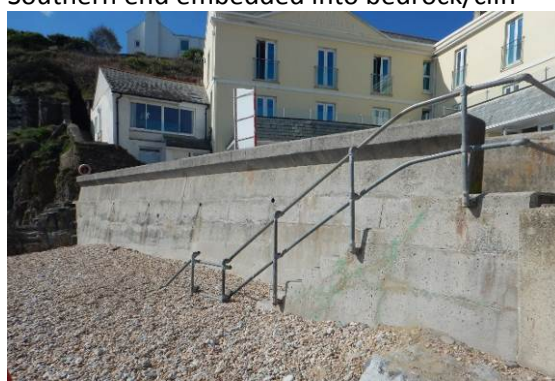
Northern end with concrete access steps

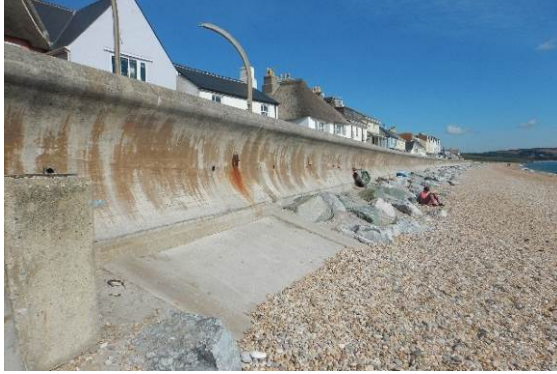
Concrete recurve wall with sloped revetment providing a flood defence to properties at Torcross

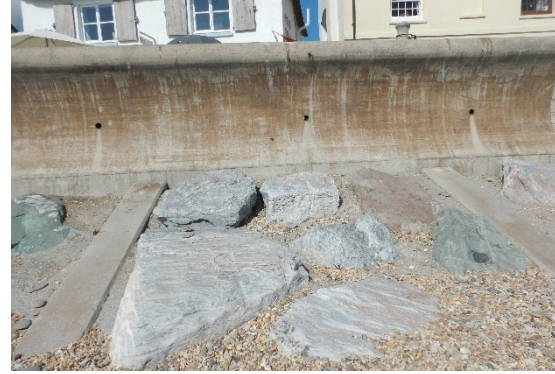
Typical section of wall showing rocks embedded in the revetment

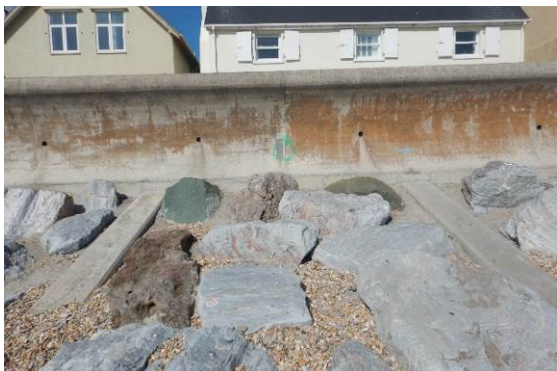
Green paint indicating the location of patch repairs

Condition Description: The wall has minor surface wear, very minor surface cracking and rust staining in places. The joints between the sections are well maintained with a few locations having new replacement sealant. The toe was covered with beach material at the time of the inspection so was not assessed, however work has been undertaken very recently to repair the toe and it is therefore assumed to be in good condition.

Condition Grade: Grade 2 – GOOD

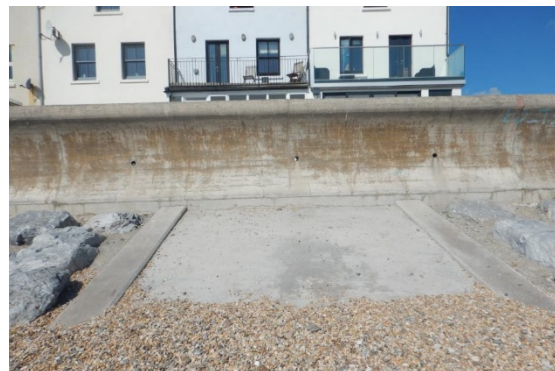
Concrete revetment with no rocks

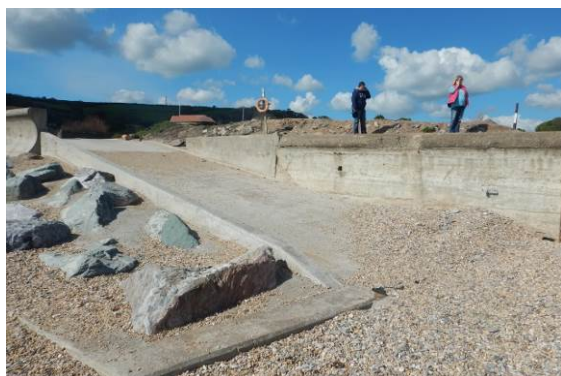
Slipway concrete wall

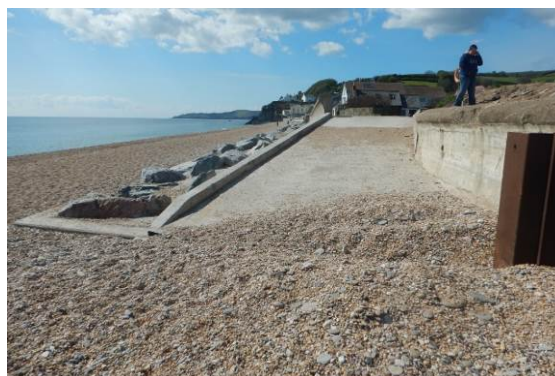
View looking south towards the slipway and wall

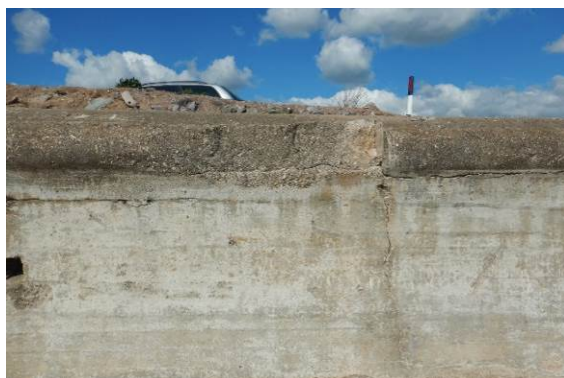
Evidence of concrete cracking

Condition Description: There is some rust staining on the seaward concrete but signs of good maintenance and replacement of sealant in joints. The old concrete seawall on the landward side of the slipway is showing signs of cracking and loss of structural concrete at the crest however there are no signs of displacement.

Condition Grade: Grade 3 – FAIR

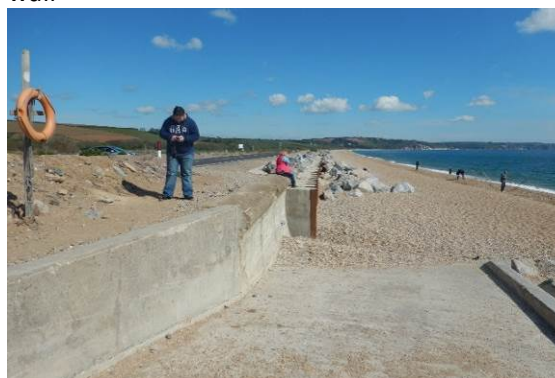
View looking north towards the adjacent sheet pile wall

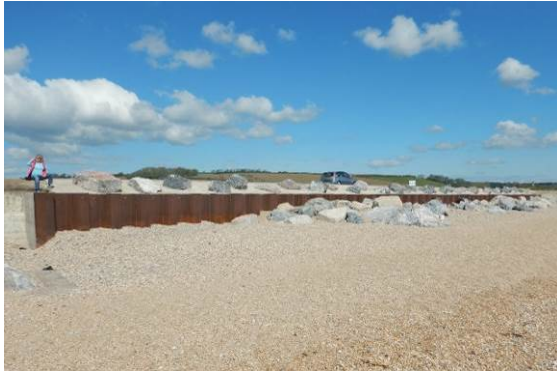
Sheet pile wall north of the slipway

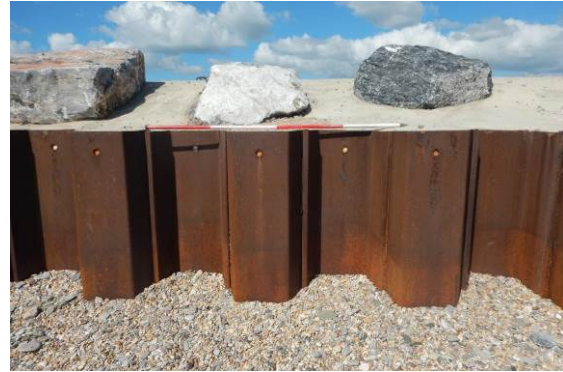
Sheet pile with 2m ranging pole for scale

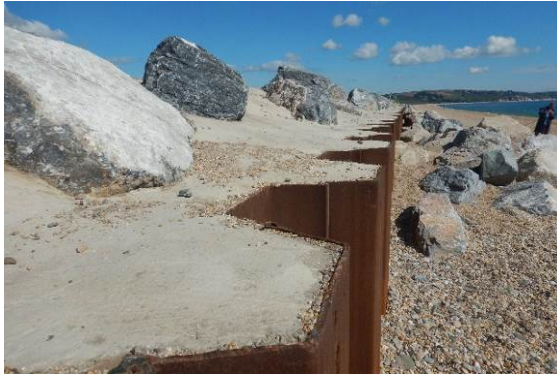
Sheet pile with concrete back fill

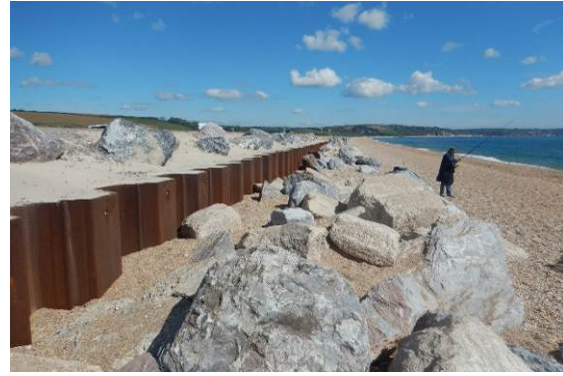
Extend of rock armour fronting the piled wall

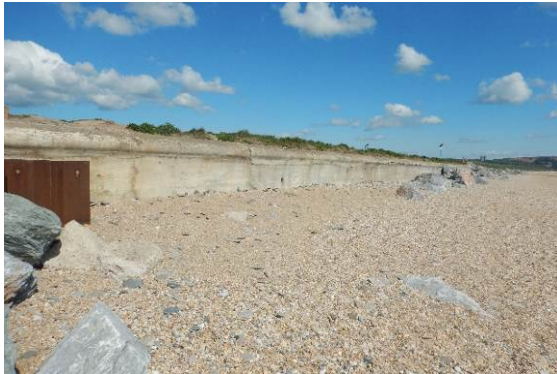
Concrete wall north of the sheet pile wall

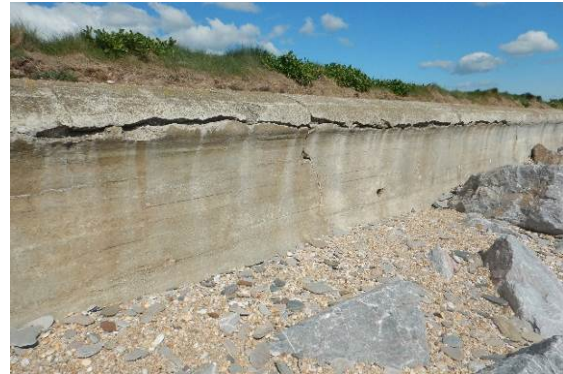
Major horizontal crack along top of the wall

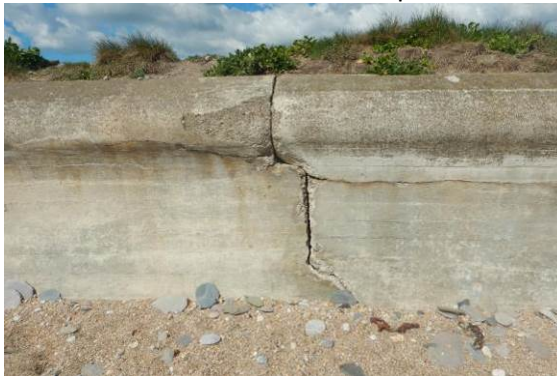
Typical vertical crack found at joints in wall

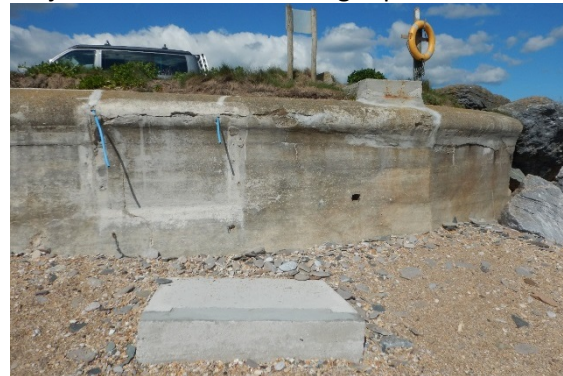
Evidence of patch repairs to northern end of wall

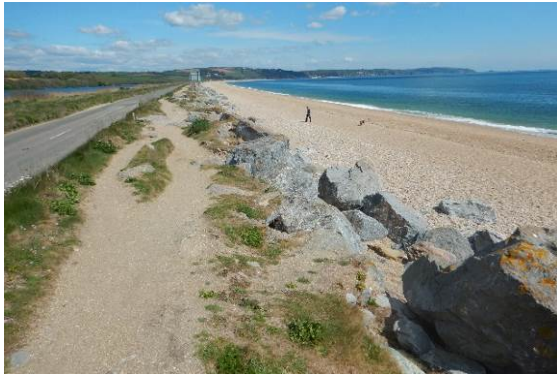
Rock protection looking north

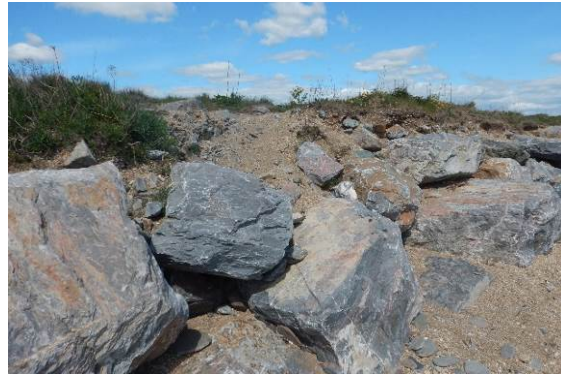
Erosion of the embankment behind the rocks

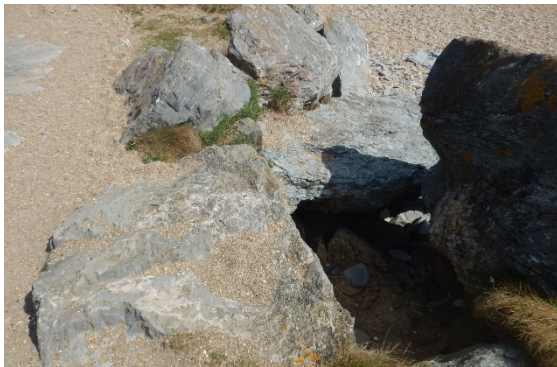
Voids present behind misplaced rocks

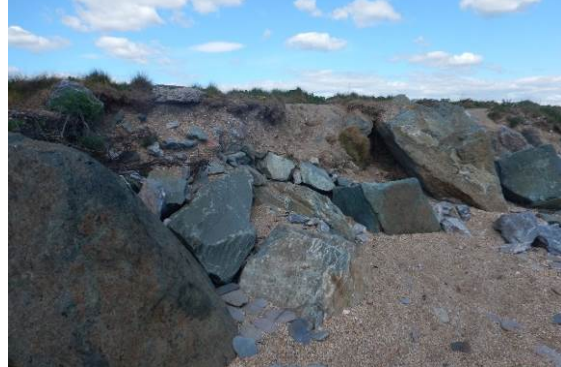
Further erosion of the bank

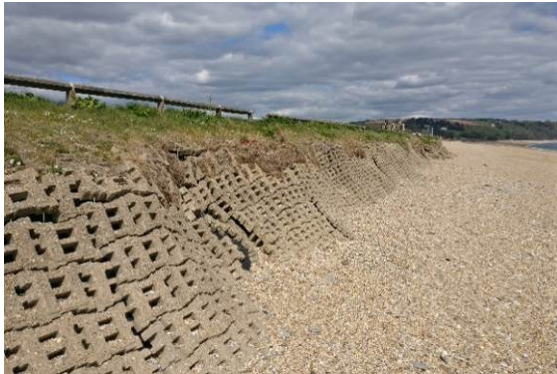
‘Armourflex’ blockwork

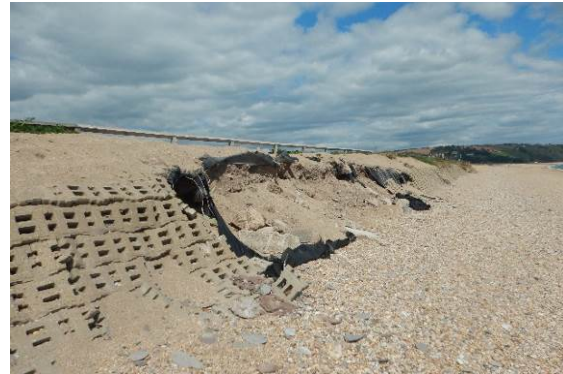
Large area exposed due to washout of blocks

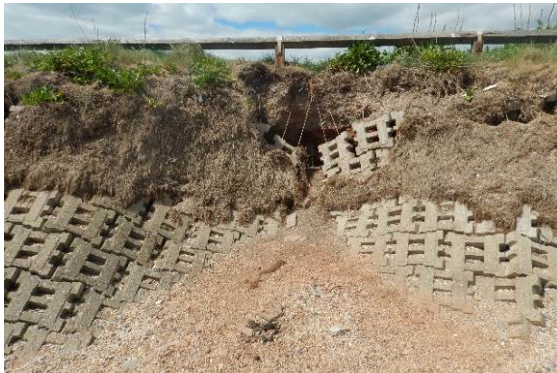
Slumping of the defence with nylon cords visible

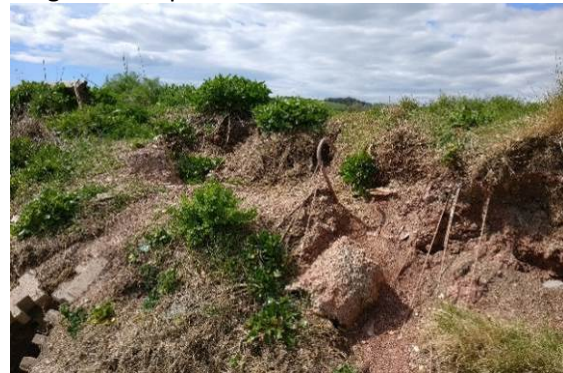
Erosion has exposed rebar peg holding nylon cords

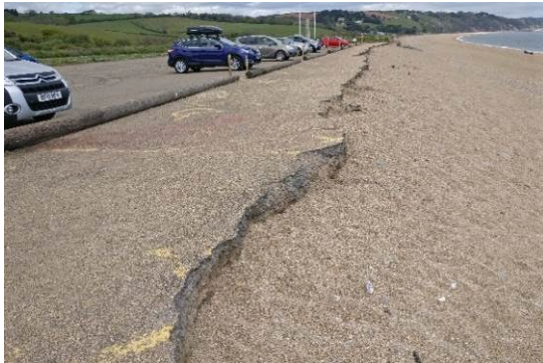
Erosion/cliffing of the beach at the car park

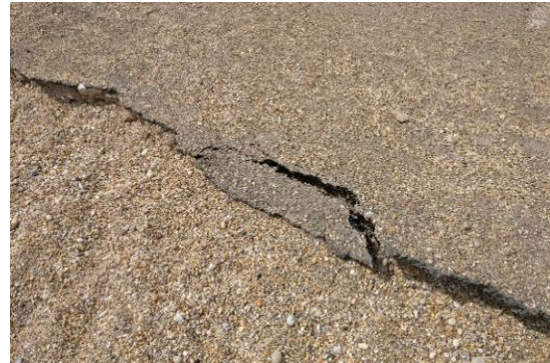
Cracking of tarmac within the car park due to undermining

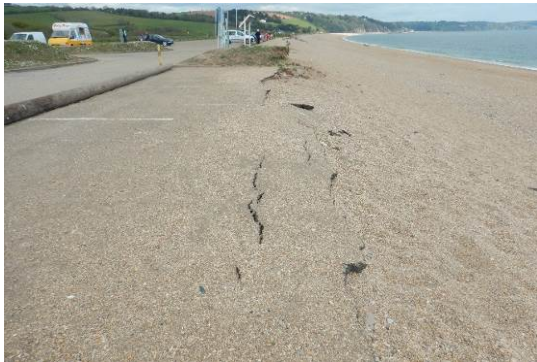
Cracking of the carpark as result of erosion

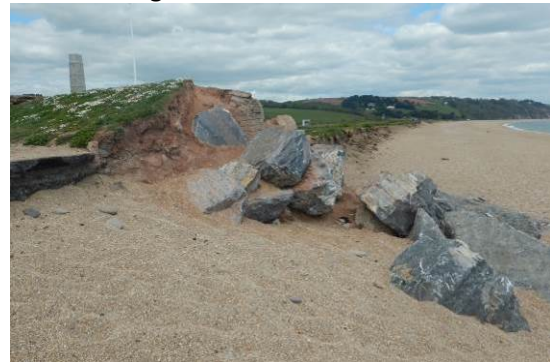
Remains of one of the failed bastions

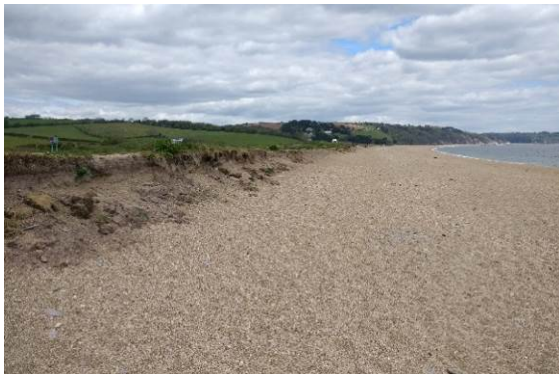
Overview of section

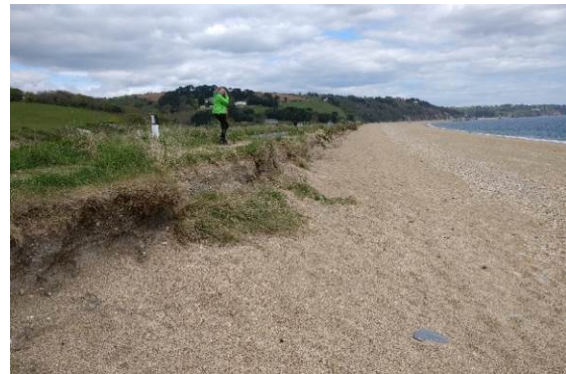
Large section of collapsed material

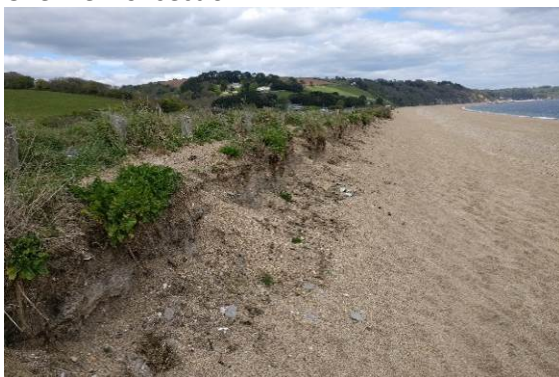
Evidence of recent erosion

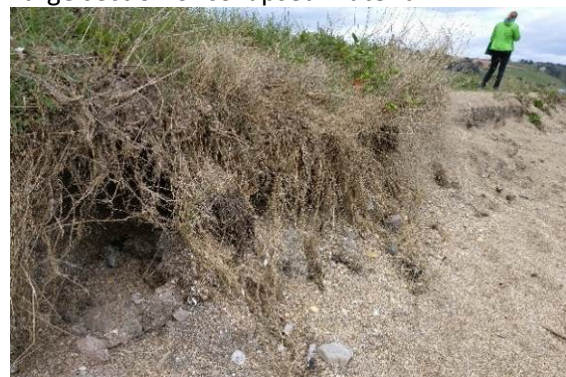
Vegetation falling away from the backshore

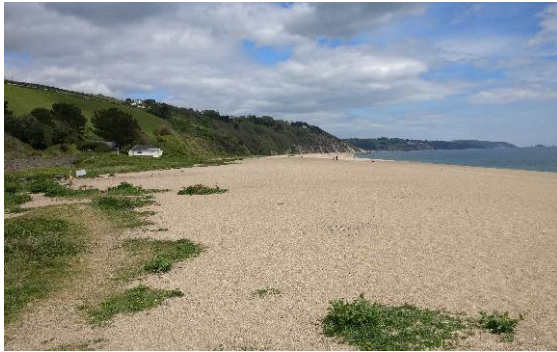
Wide and shallow beach

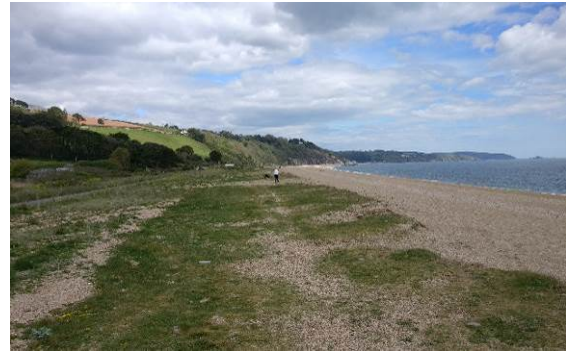
Vegetation on the back shore
