REPORT (FINAL)

Slapton Sands Beach Management Plan

Slapton Line
Partnership

February 2018

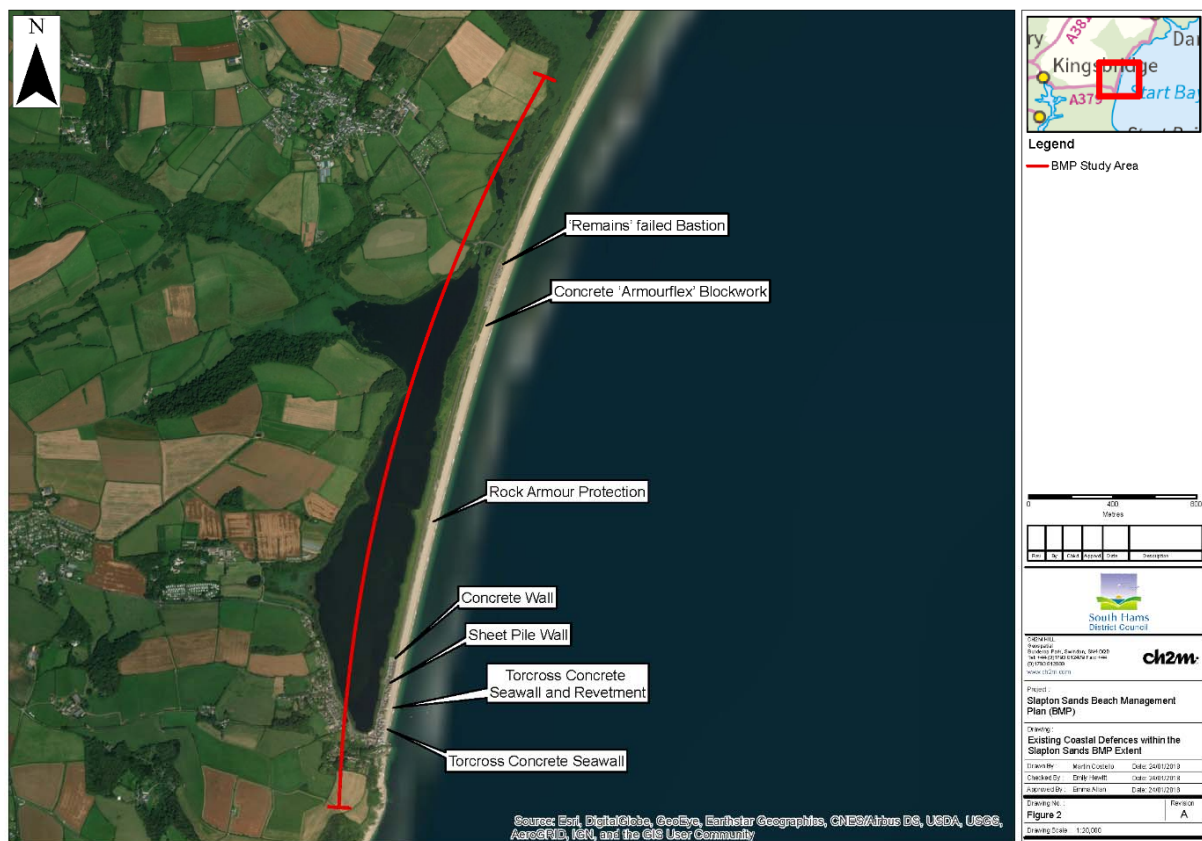
Figure 1-3 Existing coastal defences along the Slapton Sands BMP frontage

The existing coastal defences are shown in Figure 1-3, with further details provided in Section 3.

In summary, the majority of defences along the western and central end of the BMP frontage, are in fair or good condition. The seawall and sheet pile wall are in good or fair condition with a residual life of 35-40 years, due to recent emergency works completed by the Environment Agency, SHDC and DCC completed in 2016. The rock armour protection that runs along a large extent of 'The Line' appears in reasonable condition, however, it is no longer in its 1979 structural form and thus as a coastal defence is not fully serving its intended function. The concrete seawall (constructed in 1917) and the Concrete 'Armourflex' blockwork were both assessed to be in poor condition, with significantly reduced performance.

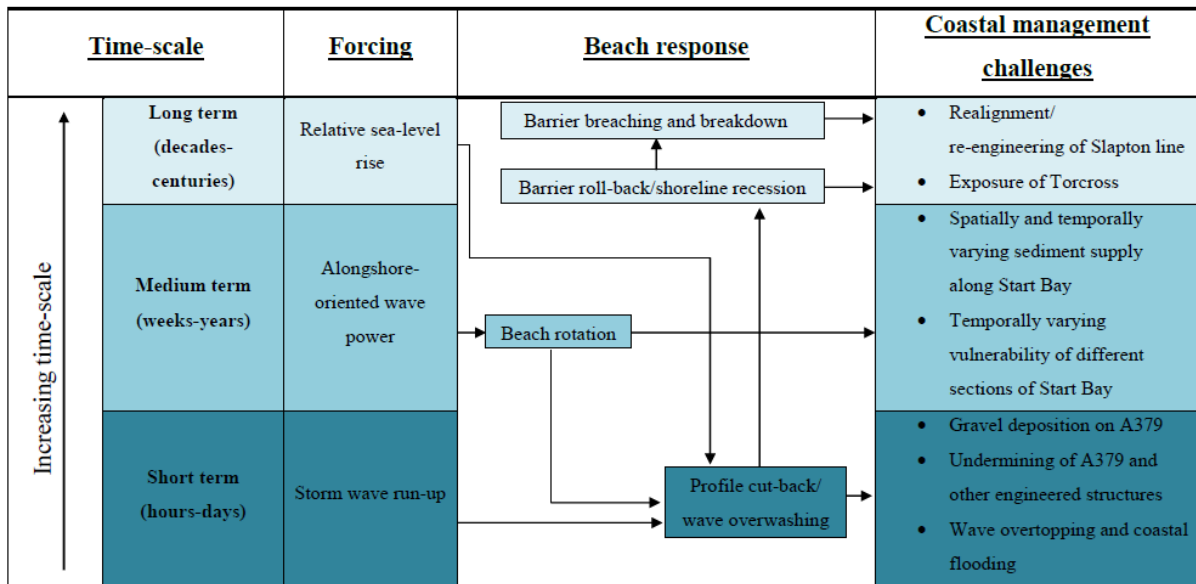
Figure 2-6 Conceptual model of key coastal processes and related management challenges in Start Bay

These interacting coastal processes cause a number of coastal management challenges (Figure 2-6). In the short-term, storm wave attack is the main concern to coastal management, as this can cause coastal flooding and undermining of the A379 road, storm defences, and other engineered structures. Over medium time-scales, the alongshore supply of sediment and resulting vulnerability of the different sections of Start Bay is a concern for coastal management. Over the long-term, the retreat of Slapton barrier will potentially expose Torcross village to the sea, and will require consideration to be given to the future of the Slapton line section of the A379 road.

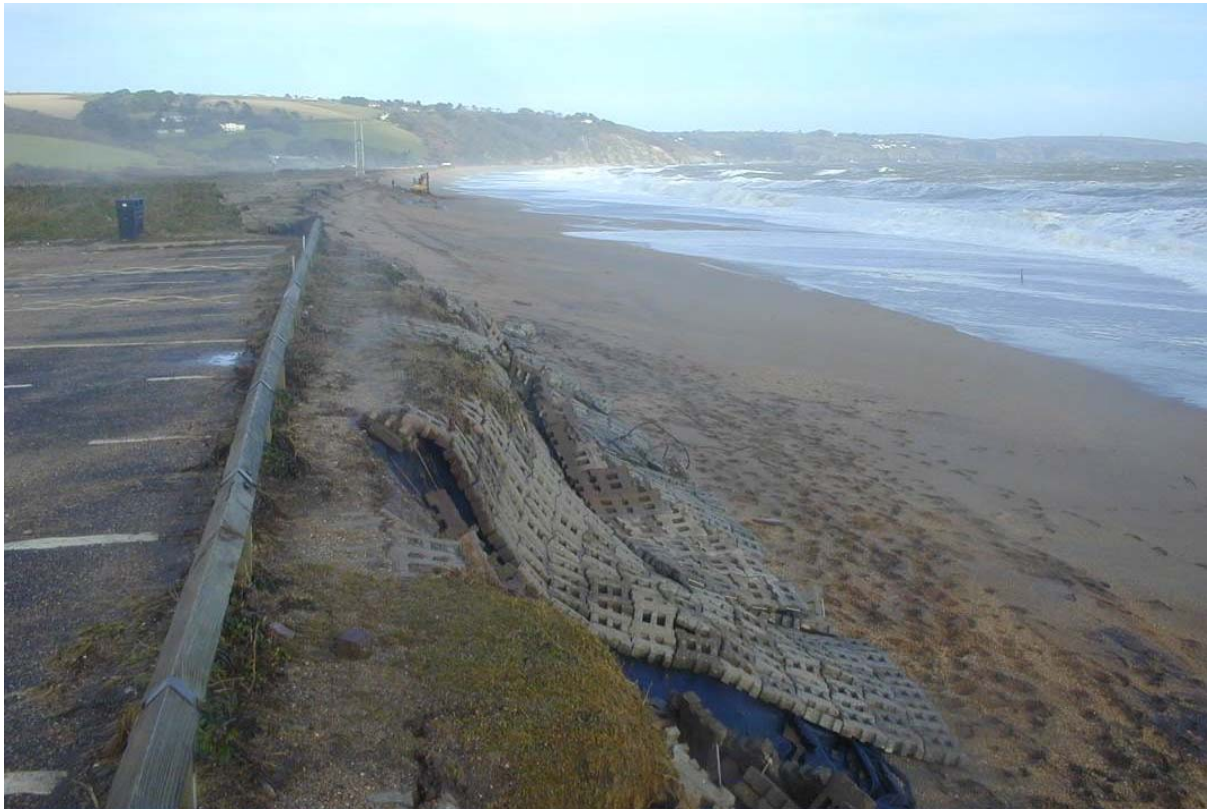
Figure 3-2 2001 Storm damaged 'armour flex' blockwork protection

In the late 1980s, 330m of concrete 'Armourflex' blockwork was installed in front of the middle car park. In 2001, the blockwork suffered from storm damage (see Figure 3-2), and today, the blockwork is in poor condition.

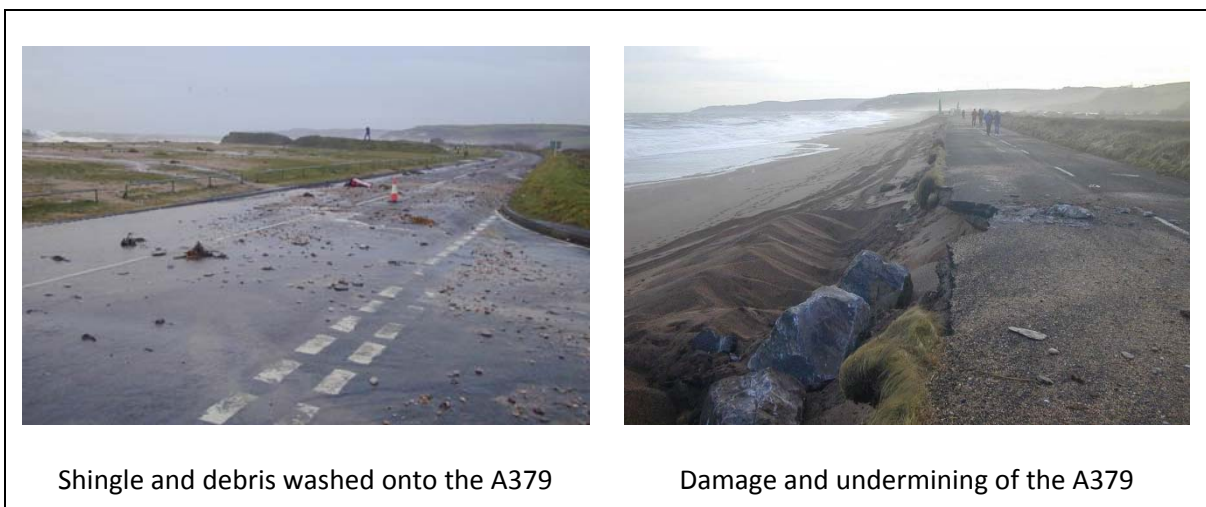
Figure 3-3 2001 storm damage to the A379

Severe storms in January 2001 caused a reduction in the crest width of 5m over a length of 1,000m (see Figure 3-3). The erosion undermined a 200m length of the A379, north of the junction with Sands Road, resulting in the temporary closure of the road.

Shingle and debris washed onto the A379

Damage and undermining of the A379

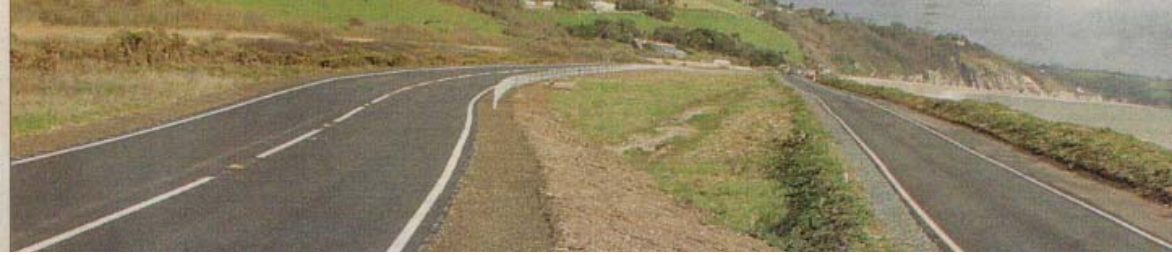
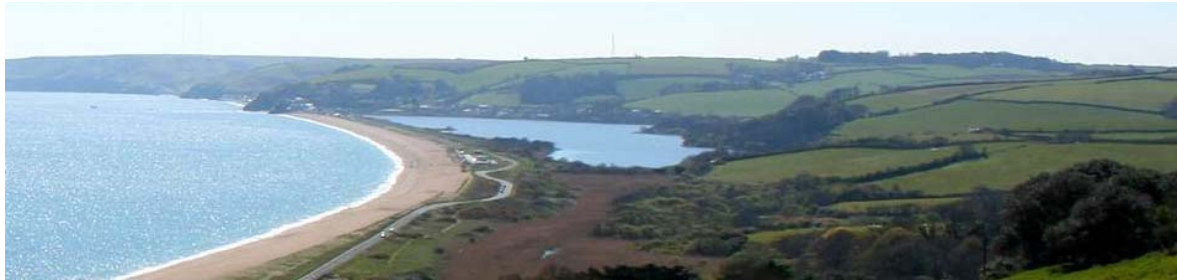
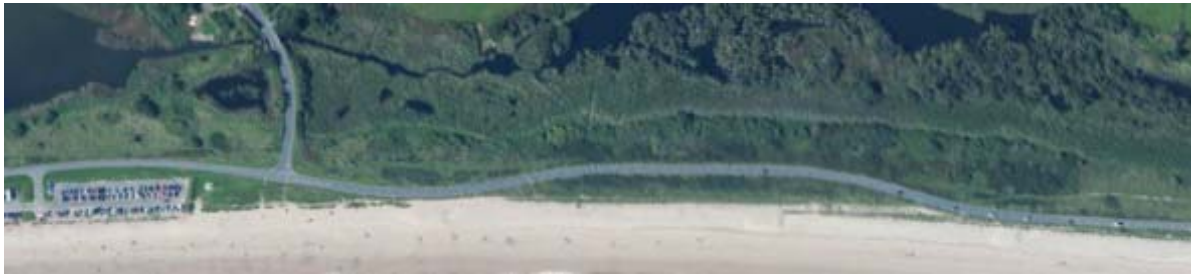
Figure 3-4 New section of road set back 21m from the existing storm damaged section

In 2002, a 250m section of the A379 adjacent to the Higher Ley had to be reinstated 20m inland. The new two-way length of carriageway replaced a temporary single road which was built after storm damage in 2001 (see Figure 3-4).

Two-lane highway realigned inland of the temporary single lane road

Realigned highway behind the beach

Satellite image of the realigned highway

- 2002: A 250m section of the A379, adjacent to the Higher Ley, was reinstated 20m inland. The new two-way length of carriageway replaced a temporary single road which was built after storm damage in 2001.

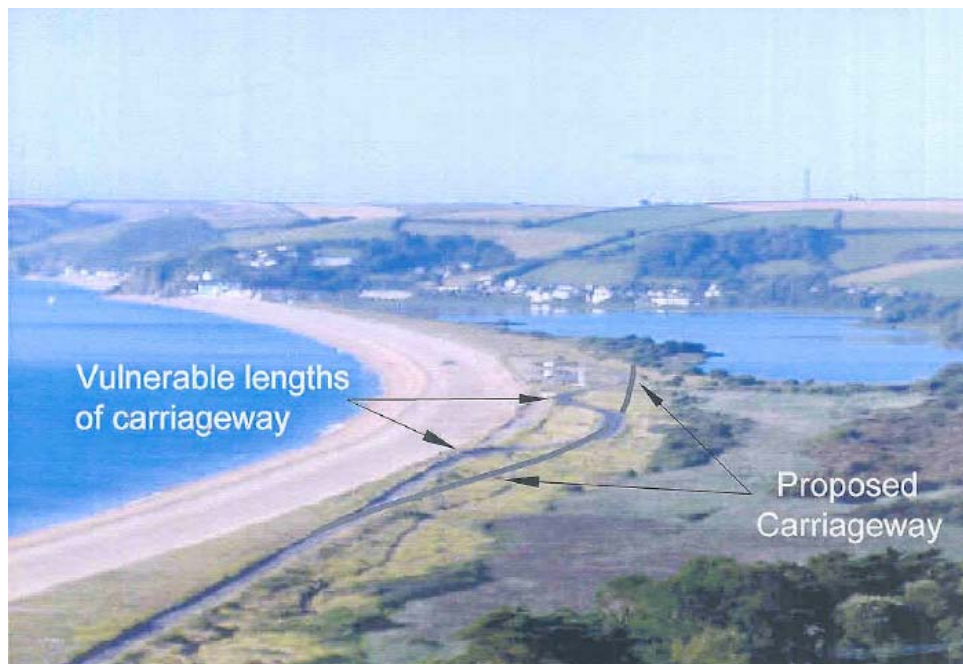
Figure 3-5 Diagram showing location of proposed A379 realignments

In 2006, a planning permission was sought to replace and realign two sections of the A379 highway between Slapton and Torcross, considered to be the most vulnerable lengths of road to storm damage. The two lengths are to the east and west of the new road constructed in 2002 (and described above). Location plans of the southern and northern sections of realignment are shown in Figure 3-5 and Figure 3-6.

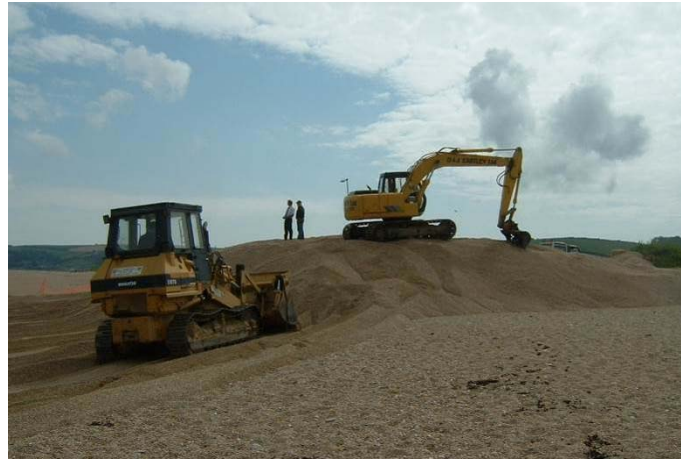
Figure 3-7 Beach material being redistributed over bastion

In 2005, a number of bastions were installed along the back of the beach to protect the car park and monument area with the placement of beach material over the bastions (shown in Figure 3-7). Further bastion replenishment works were undertaken in 2009.

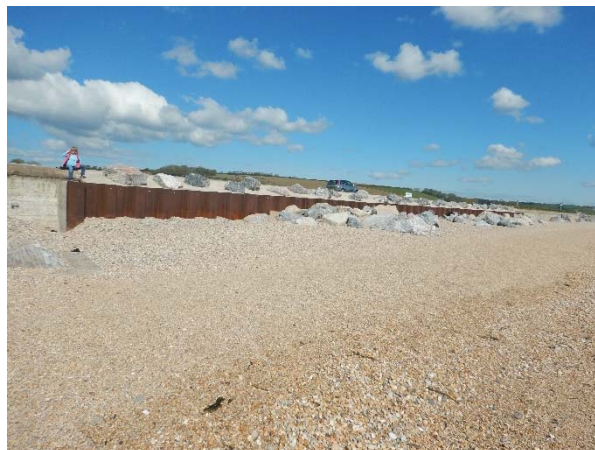
Figure 3-10 Repaired ~60m section of concrete seawall, showing sheet piles, rock/concrete crest protection and rock armour at the toe

Photograph taken during coastal defence condition assessment on 27th April 2017, looking north-east

- 2016: Former concrete seawall damaged by storms in February 2016 replaced by 4m deep sheet piling with rock/concrete crest protection and intermittently placed rock armour at the toe of the structure.

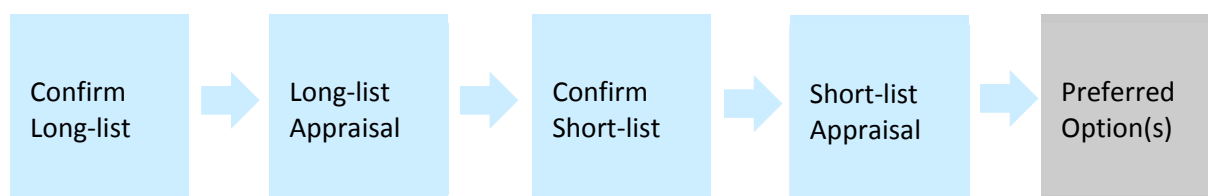
The approach to managing the coastline between Torcross and Strete Gate was developed via a robust options appraisal process and ongoing stakeholder engagement (see also Section 1.3). The selection of a preferred management approach for the BMP frontage was undertaken via a staged approach, which rationalised a long-list of options to a short-list of options, from which a preferred option(s) was selected. This is shown in Figure 4-1.

Figure 4-1 Options appraisal process – staged approach to option selection

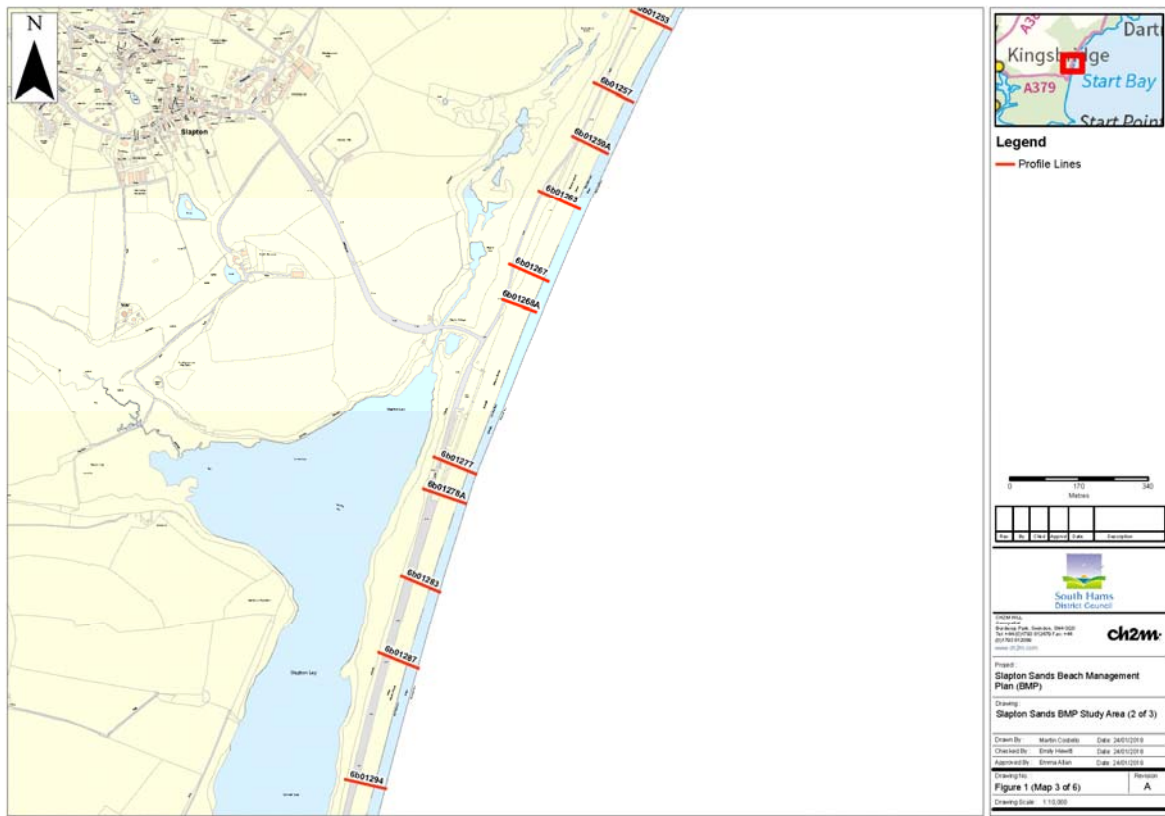
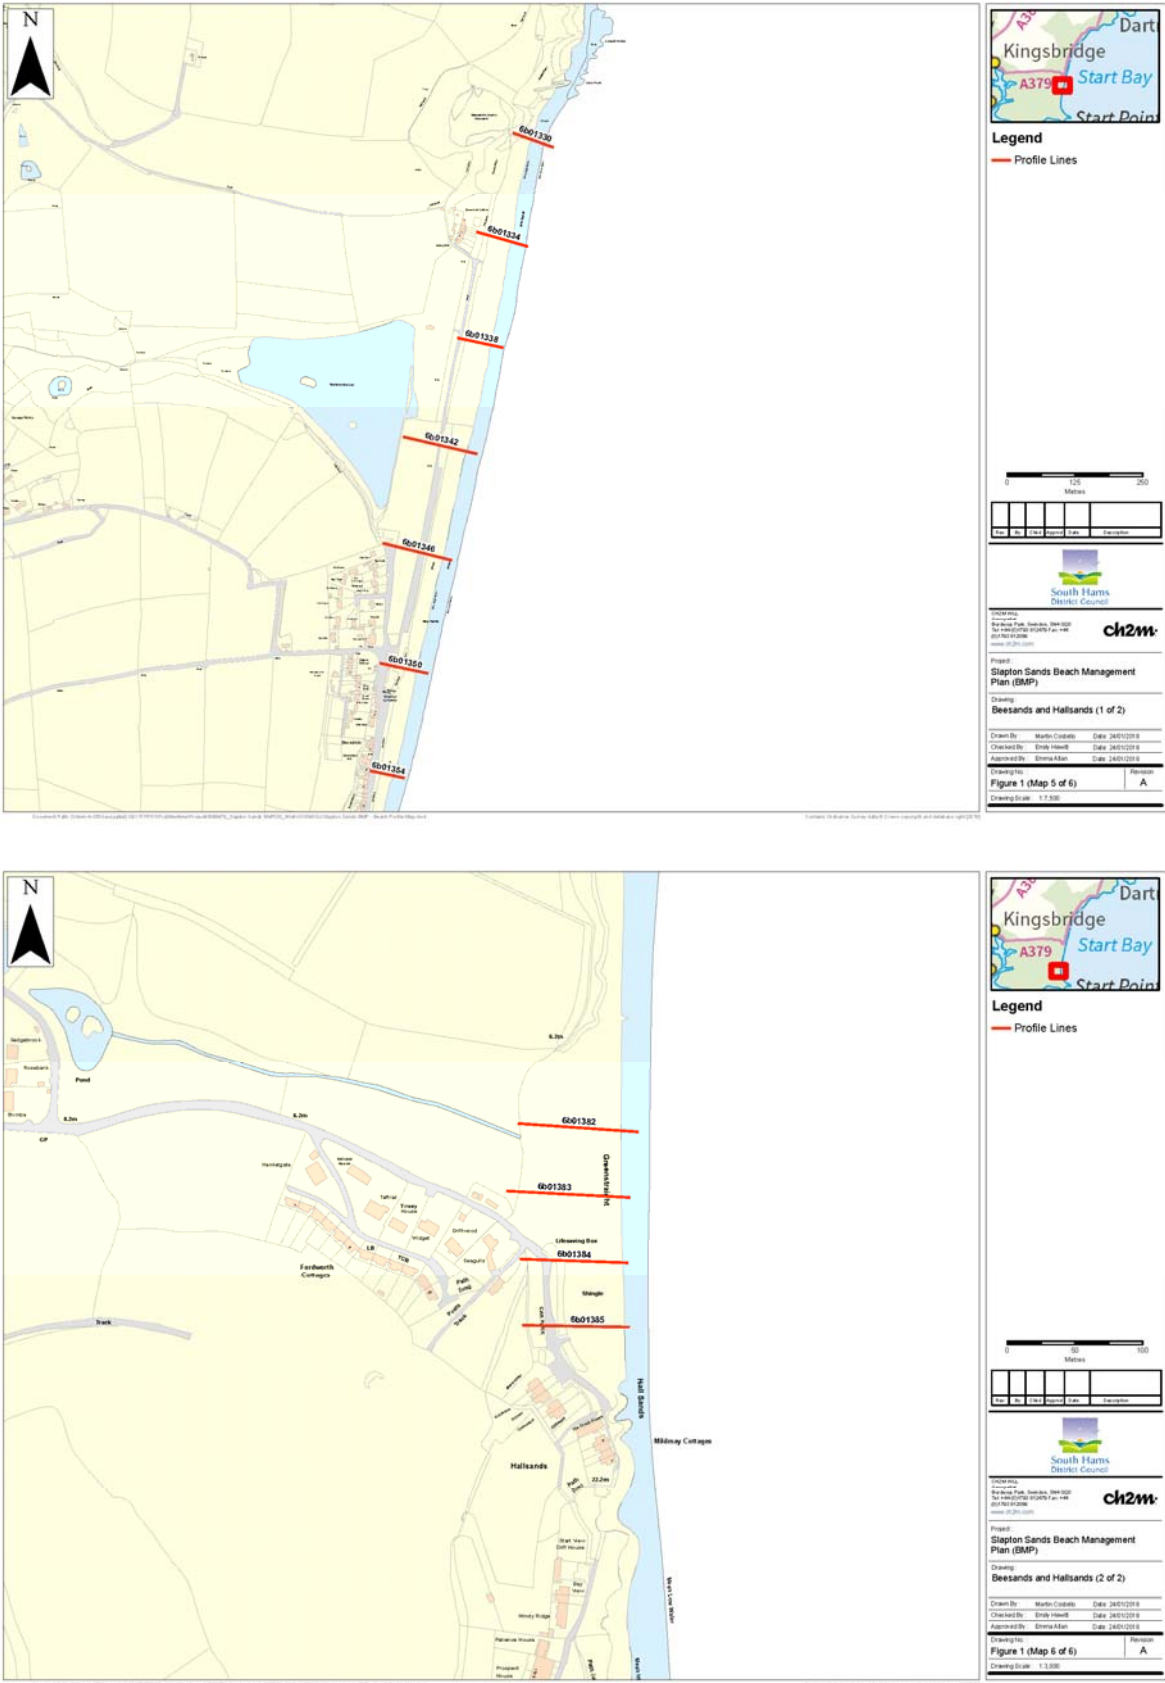
Figure 5-1 PCO beach profile survey locations

A summary of the beach profile locations is provided in Table 5-2, and includes origin co-ordinates and dates of first and most recent surveys. It also shows which profiles are currently surveyed twice per year, and which of those are also currently used to capture additional post-storm survey profiles (NB: these currently used profiles have not always been used for this purpose; in the past other profiles were used).

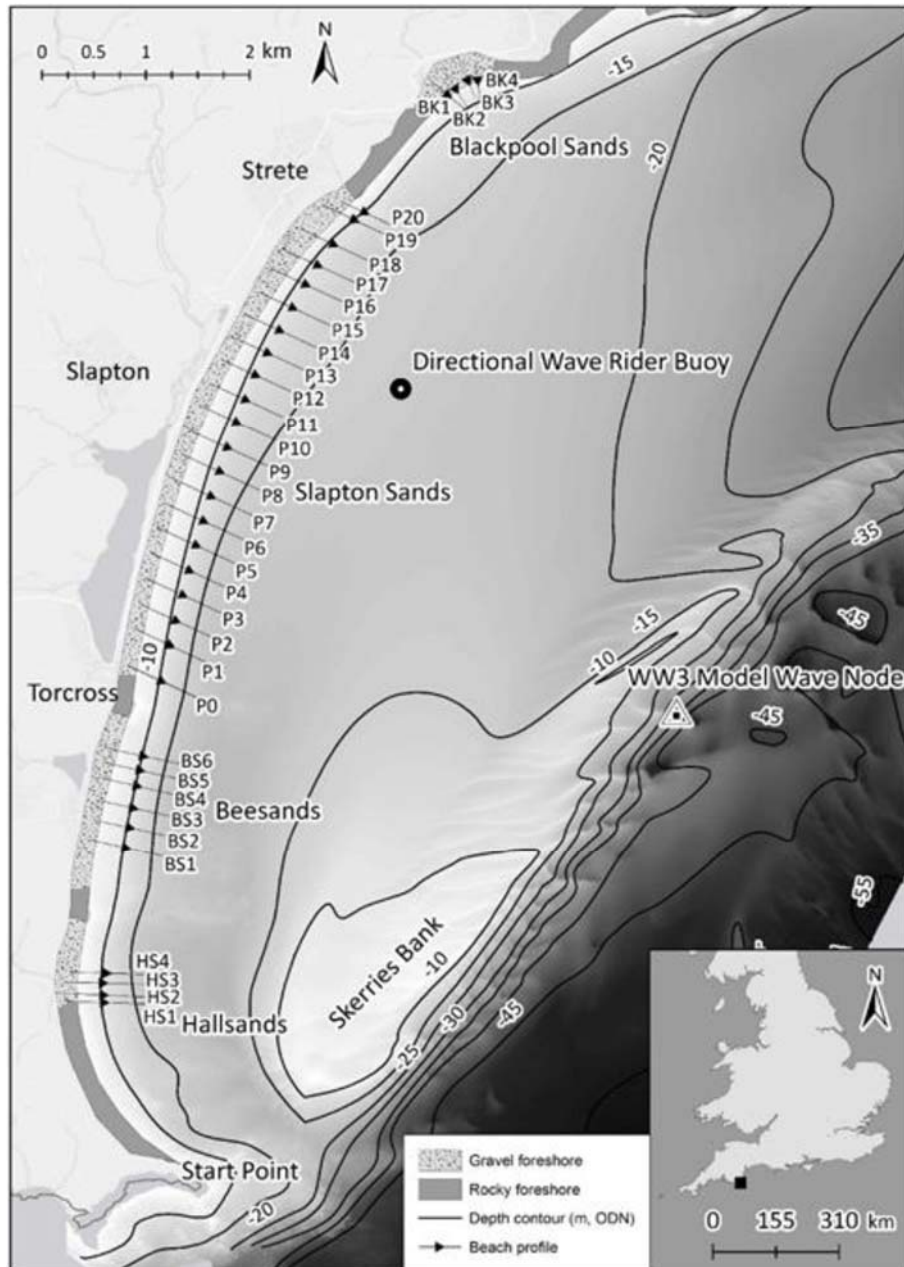
Figure 5-2 Plymouth University beach profile monitoring locations

Since November 2006, Plymouth University have undertaken monthly surveys of the beach at Slapton between Torcross and Strete. The location of the profiles, numbered P0 to P20 are shown in Figure 5-2.
