Defence Baseline Report

Prepared for

Slapton Line
Partnership

September 2017

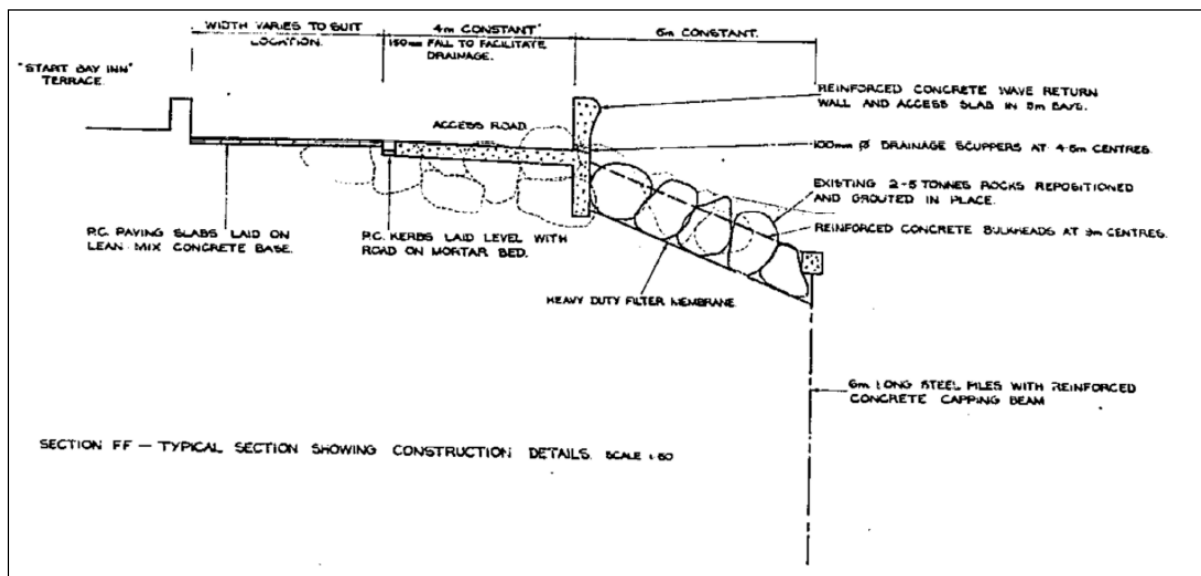
Figure 2.1 1979 as-built drawing of the Torcross seawall (EA, 2016a)

| Year | Construction/ Event | Description | Source |
|---|--|--|--|
| 1979-1980 | Torcross seawall constructed | A seawall at Torcross was constructed in 1979, with the following principle elements (see Figure 2.1 for original As-Built drawing): 6m steel sheet piled toe with concrete capping beam (toe level at 3.00m ODN); 5m wide revetment with rock cast in concrete (1 in 2.5 slope); and Recurved seawall (crest level at 6.25m ODN). Natural geomorphological change covered the rock revetment with beach material for approximately 30 years. | Torcross Emergency Work Assessment (EA, 2016a) |

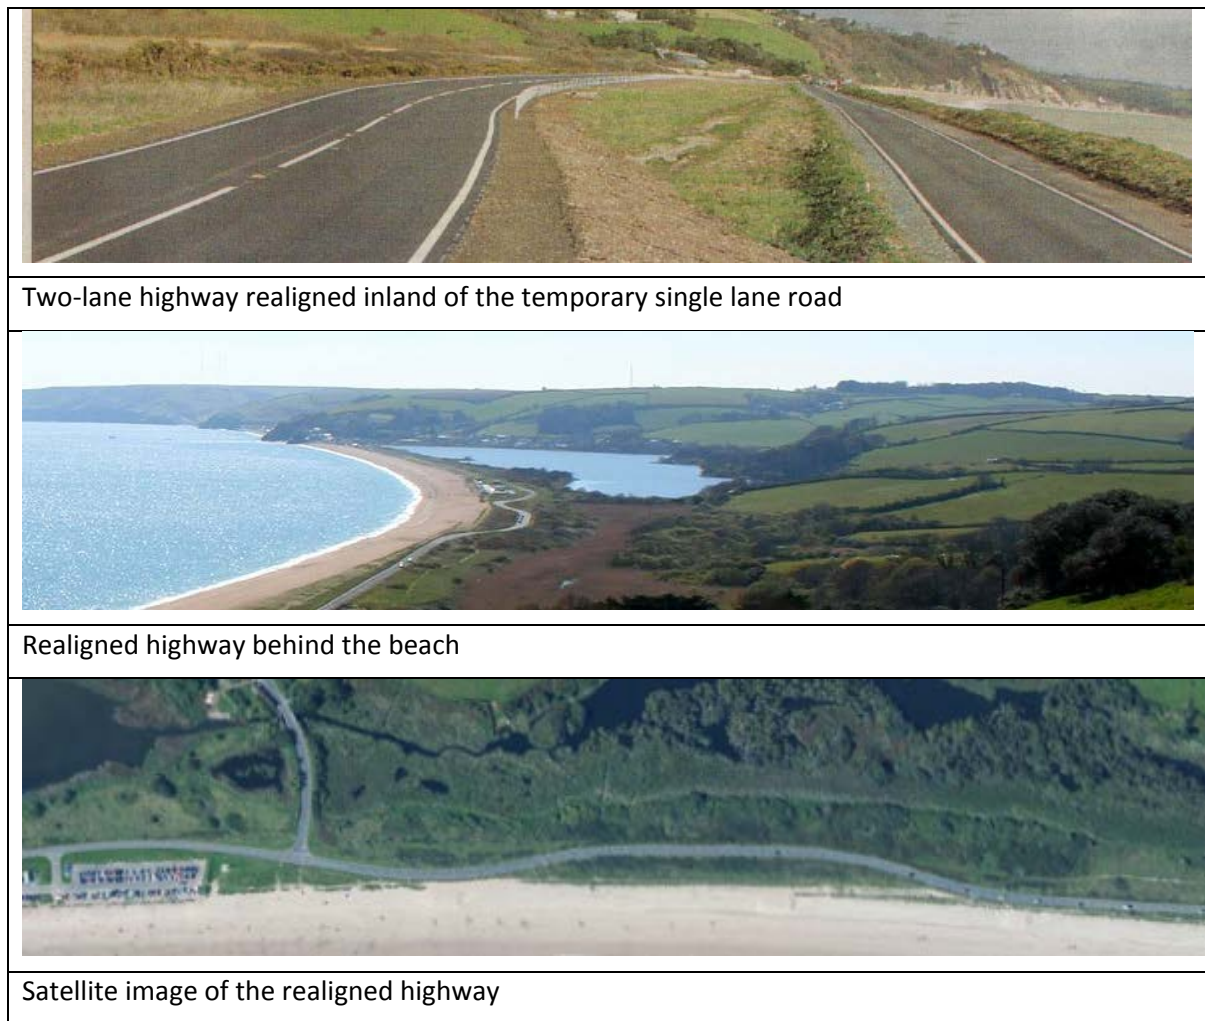
Figure 2.3 New section of road set back 21m from the existing storm damaged section

| Year | Construction/ Event | Description | Source |
|---|--|--|--|
| 2002 | Road realignment | A 250m section of the A379 adjacent to the Higher Ley had to be reinstated 20m inland. The new two-way length of carriageway replaced a temporary single road which was built after storm damage in 2001 (see Figure 2.3). Due to the sensitivity of the site an Environmental Impact Assessment was undertaken. | Planning Application (DCC, 2006). SCZM (Scott Wilson, 2006) |

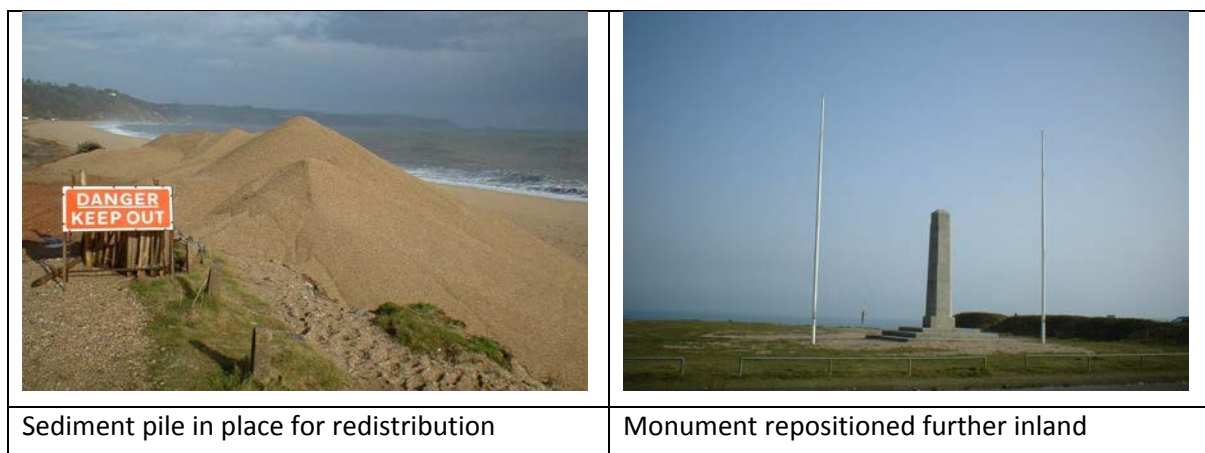
Figure 2.4 2003 beach redistribution and monument placed further inland

| Jan 2003 | Beach redistribution | Beach redistribution and new monument built (see Figure 2.4). | South Hams District Council (SHDC) |

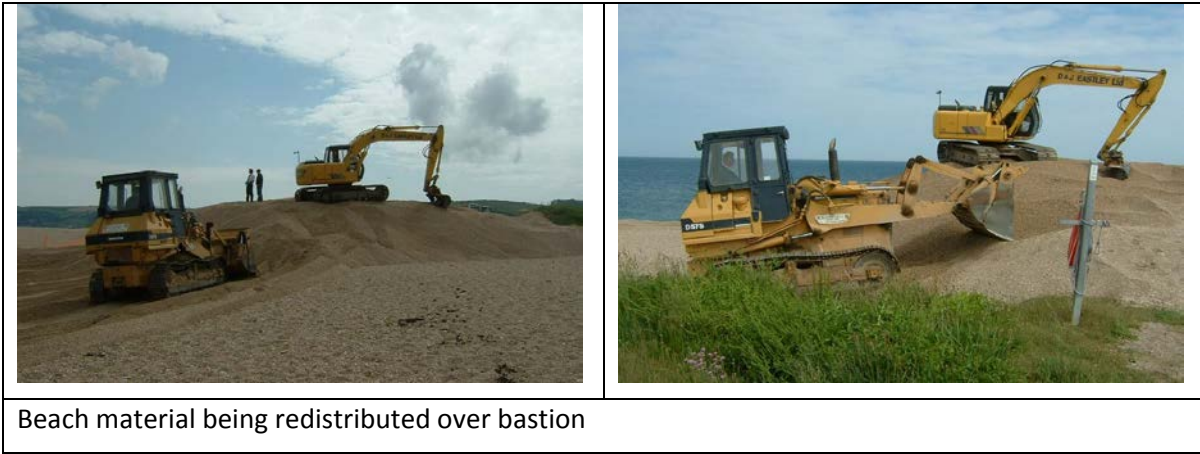
Figure 2.5 2005 bastion construction

| 2005 | Bastion management | Bastions were installed along the back of the beach to protect the car park and monument area (see Figure 2.5). | SHDC |

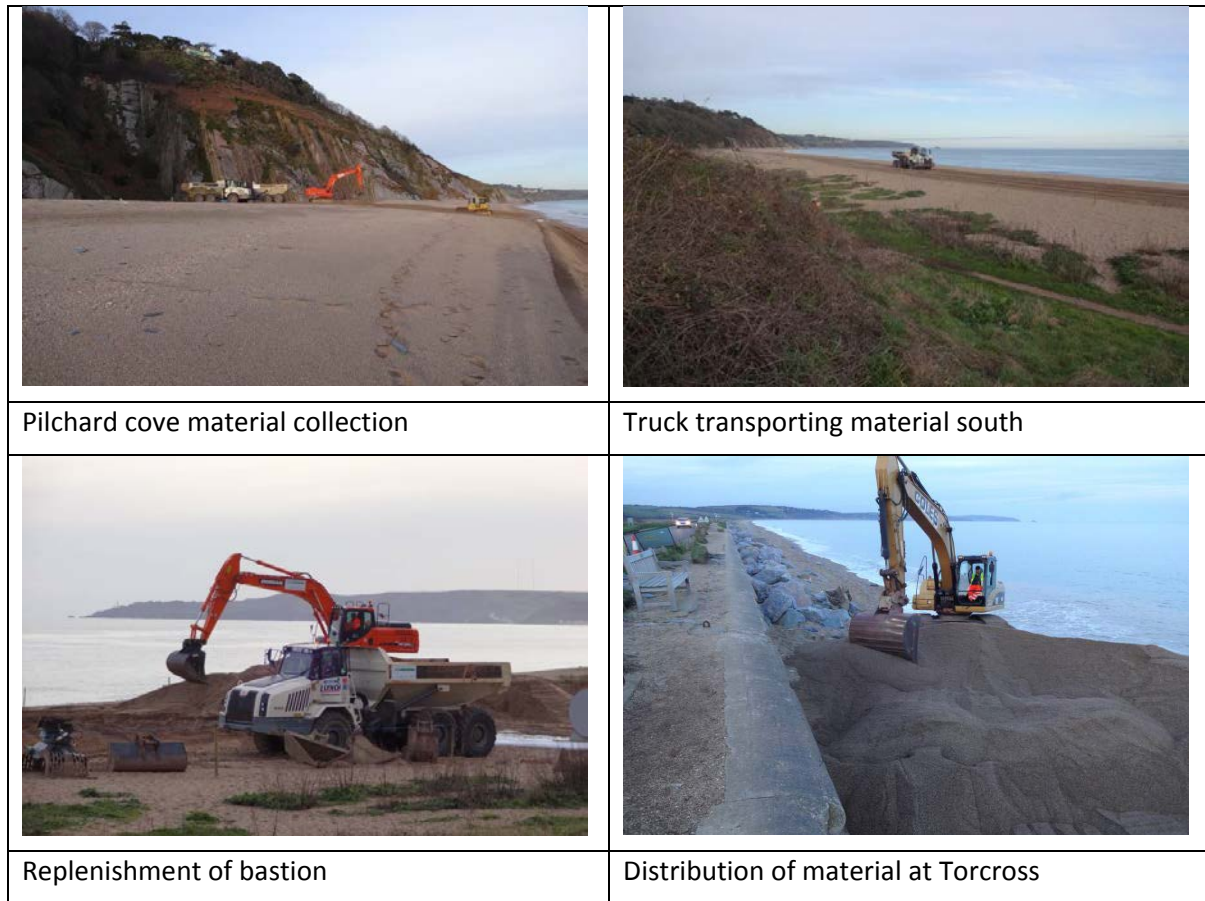
| Feb 2015 | Torcross Shingle Recycling and Bastion replenishment | <p>After the 2014 storms, the beach levels in front of the Torcross defences did not recover as quickly as was anticipated.</p> <p>A shingle recycling project was undertaken by SHDC along the Slapton line, including the deposition of shingle from Strete gate at Torcross and the construction of six shingle bastions.</p> <p>17,041m³ of material was excavated from Pilchard Cove with: 3,855m³ deposited at Torcross Point; and 13,186m³ deposited at six Bastions.</p> <p>Material was collected from within the same coastal cell, at the northern end of Slapton beach (Pilchard Cove).</p> <p>See Figure 2.8 and Figure 2.9 to see the General Arrangement drawing and photos of this work.</p> | <p>Torcross Shingle recycling-Technical Briefing</p> <p>Torcross Emergency Works Findings Report, (Mott MacDonald, 2016)</p> |

2015 shingle recycling and bastion replenishment photos

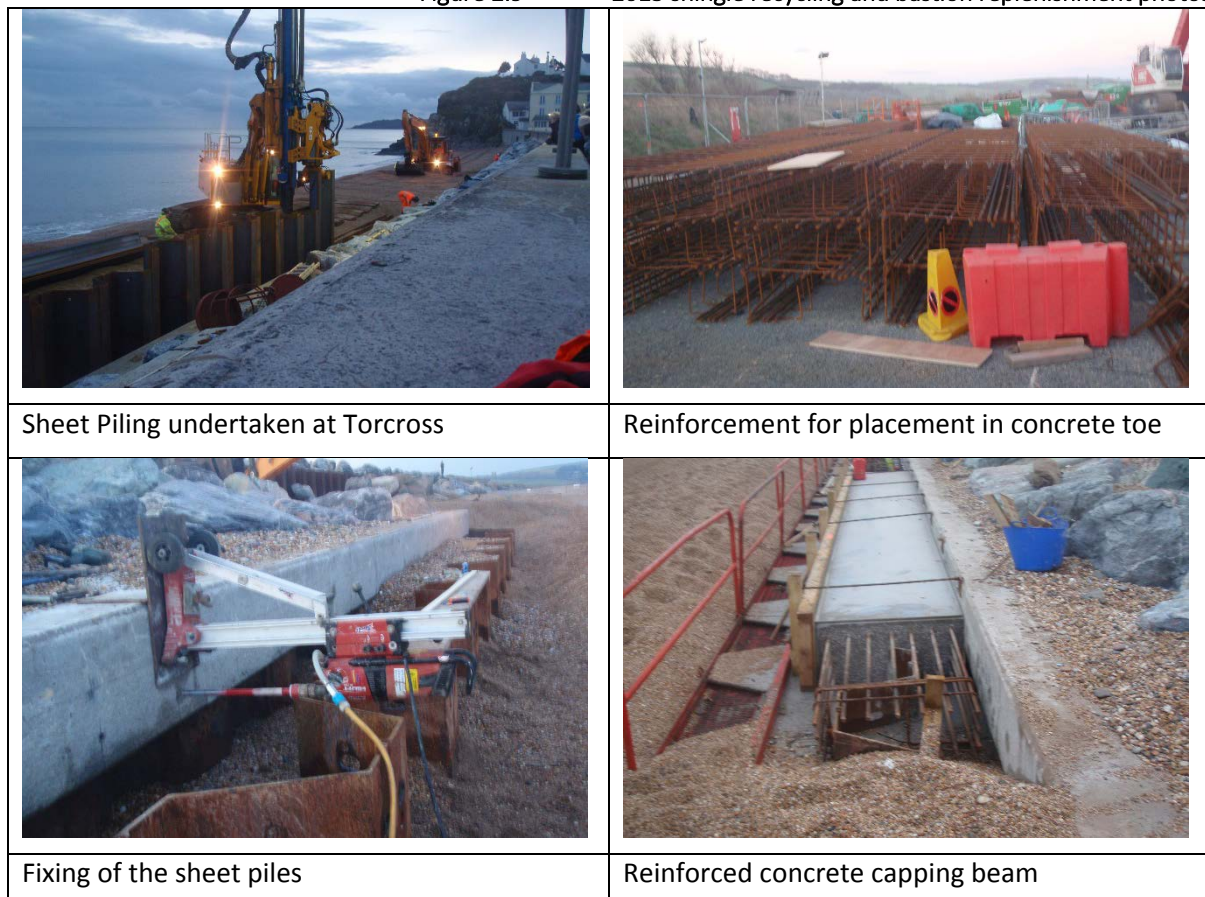
| Nov 2016 – Jan 2017 | Torcross Emergency Works | Piling and reinforced concrete capping beam added to the site along the Torcross seawall frontage. The works were completed in March 2017. See Figure 2.10 and Figure 2.11 for photos and as-built drawing of the work. | Torcross Weekly Progress Reports, (CH2M HILL, 2017) |

2016/2017 Torcross seawall emergency works photos
